**RE: Albuquerque Vault Company; Industrial Permit; SIC 3272; NPDES Compliance
Evaluation Inspection; NPDES NMU001933; April 12, 2017**

NPDES Compliance Inspection Report

Albuquerque Vault Company
NMU001933
April 12, 2017

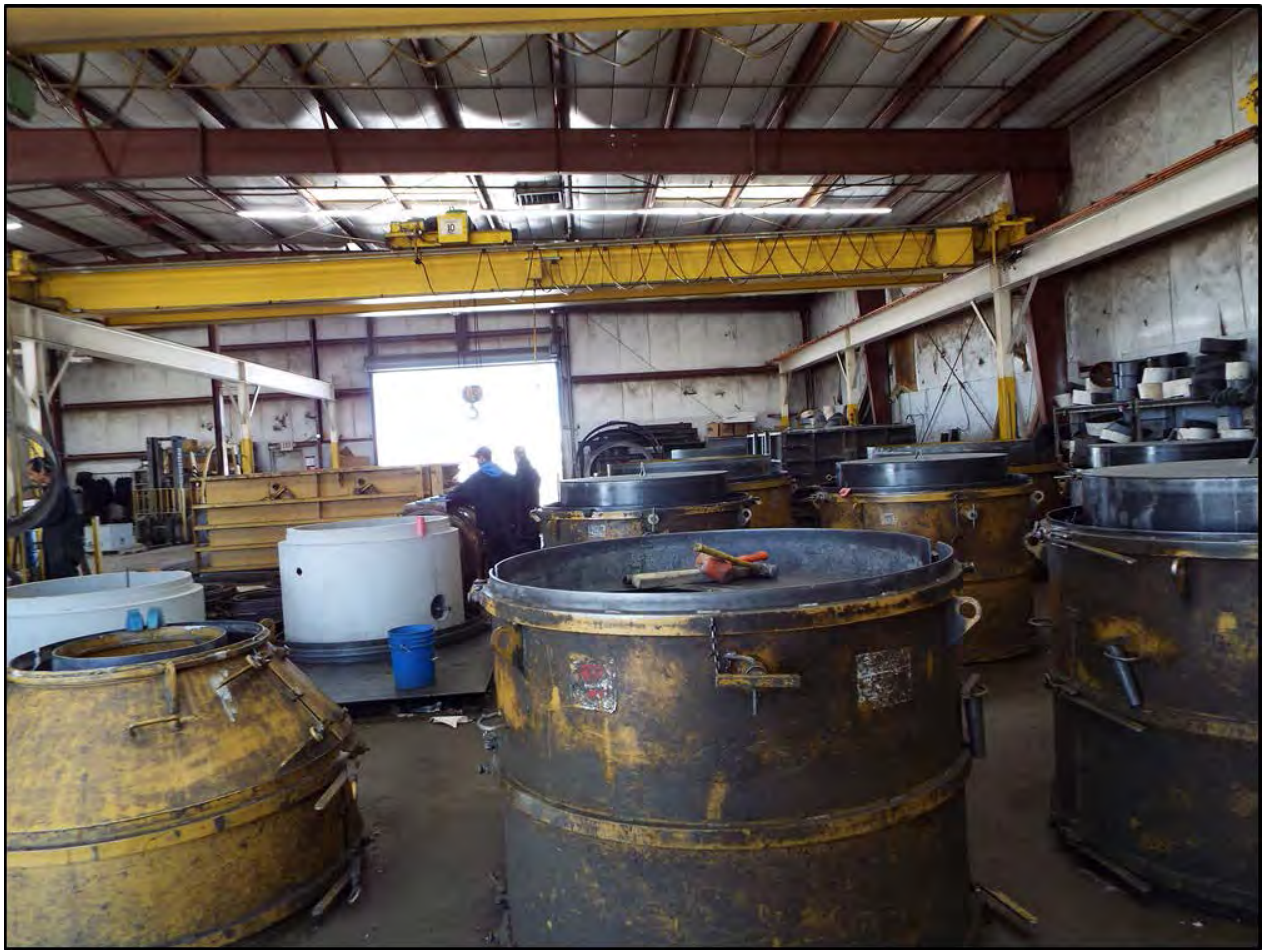
Photo # 1

Photographer: Daniel Valenta	Date: 4/12/2017	Time: 1114 hours
City/County: Albuquerque/Bernalillo		
Location: 300 Airport Rd. NW		
Subject: Concrete is poured into metal molds inside an enclosed shop.

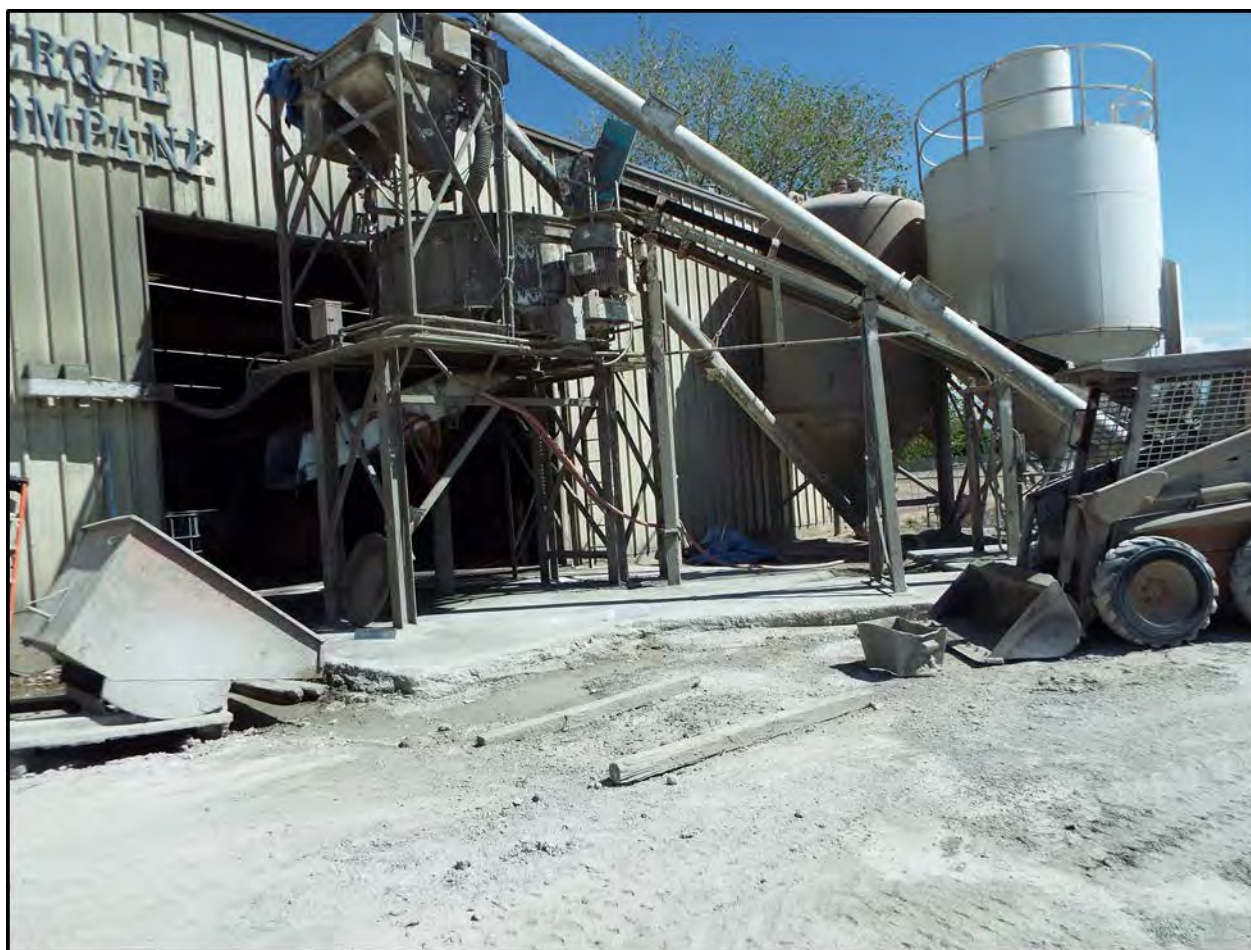
Photo # 2

Photographer: Daniel Valenta	Date: 4/12/2017	Time: 1116 hours
City/County: Albuquerque/Bernalillo		
Location: 300 Airport Rd. NW		
Subject: Raw materials are stored in silos outside of shop.

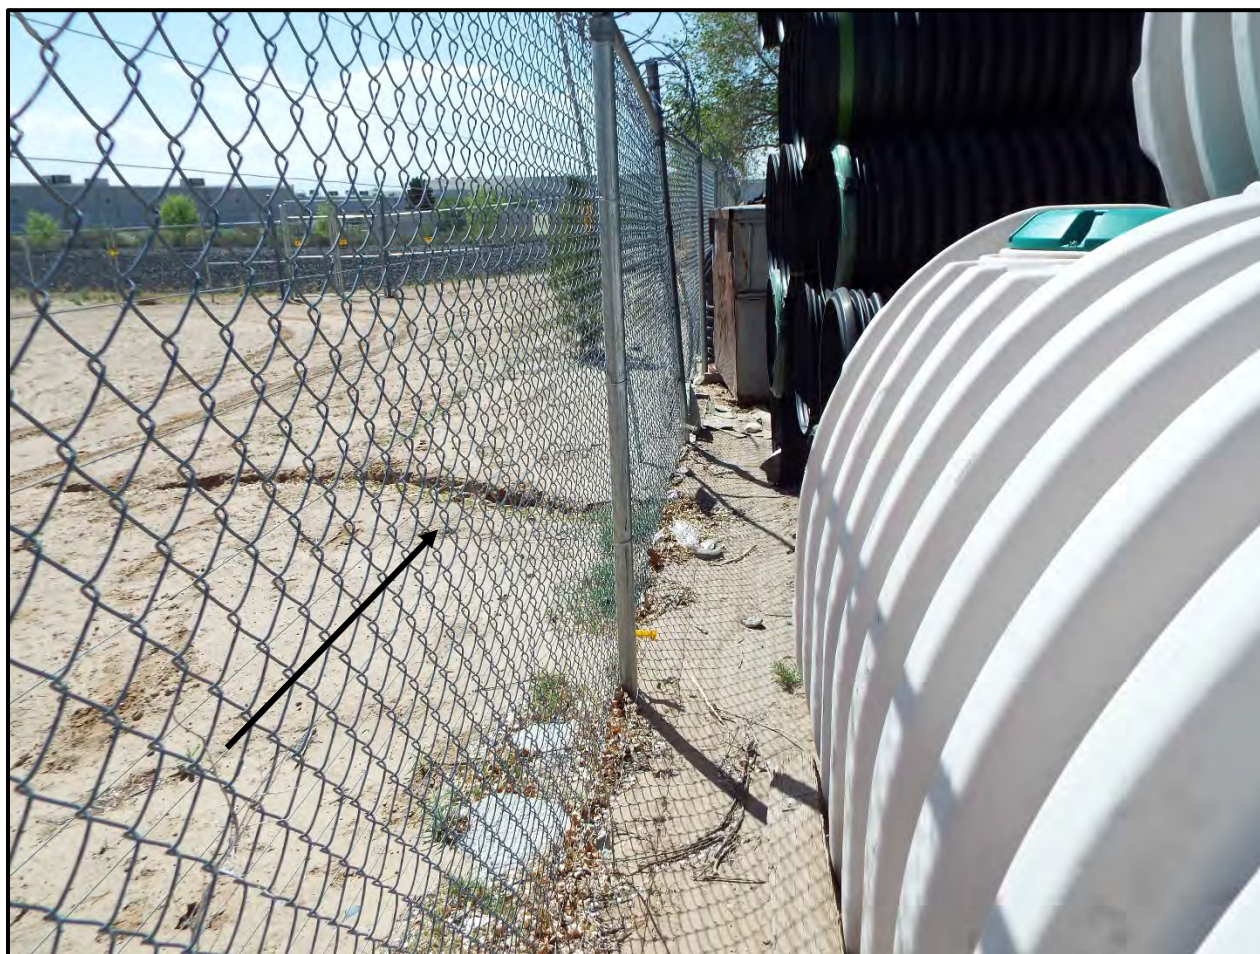
Photo # 3

The site appeared to be fairly level, there were several small depressions where water would collect. Close to the raw materials storage area is a pit where wash water is directed and rain water falling on the raw materials would flow. Along the east side of the property there appeared to be several spots along the fence where discharges were occurring from the roof and scrap storage areas. There was no BMP in place to prevent track out at the entrance/exit of the facility. The site was organized and clean. The mixing and pouring of concrete into the forms is conducted within a large building and not open to stormwater. See attached photo's.

Photographer: Daniel Valenta	Date: 4/12/2017	Time: 1103 hours
City/County: Albuquerque/Bernalillo		
Location: 300 Airport Rd. NW		
Subject: Discharges from facility down cut rills on property next to site.

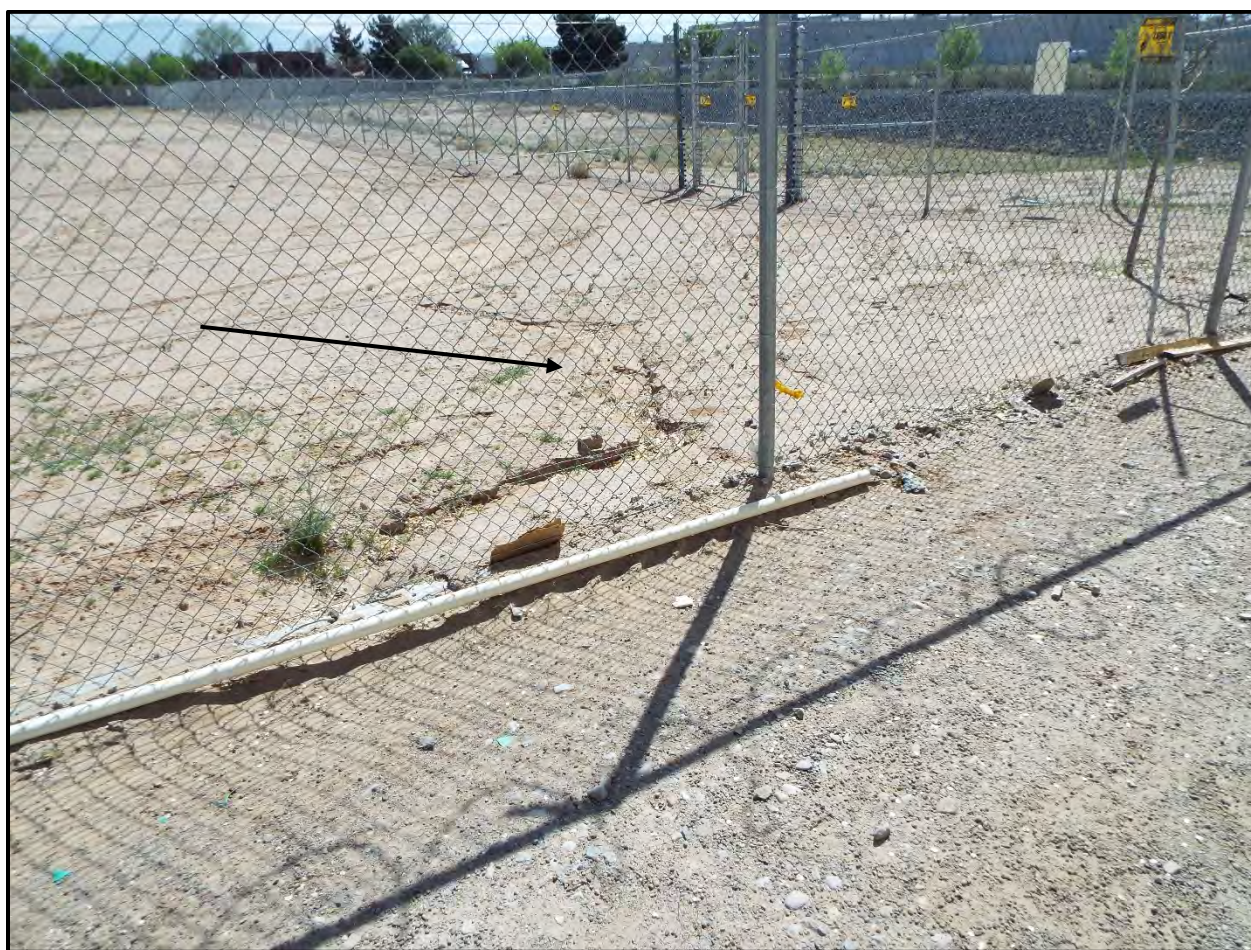
Photo # 4

Photographer: Daniel Valenta	Date: 4/12/2017	Time: 1100 hours
City/County: Albuquerque/Bernalillo		
Location: 300 Airport Rd. NW		
Subject: Discharges from facility down cut rills on property next to site.

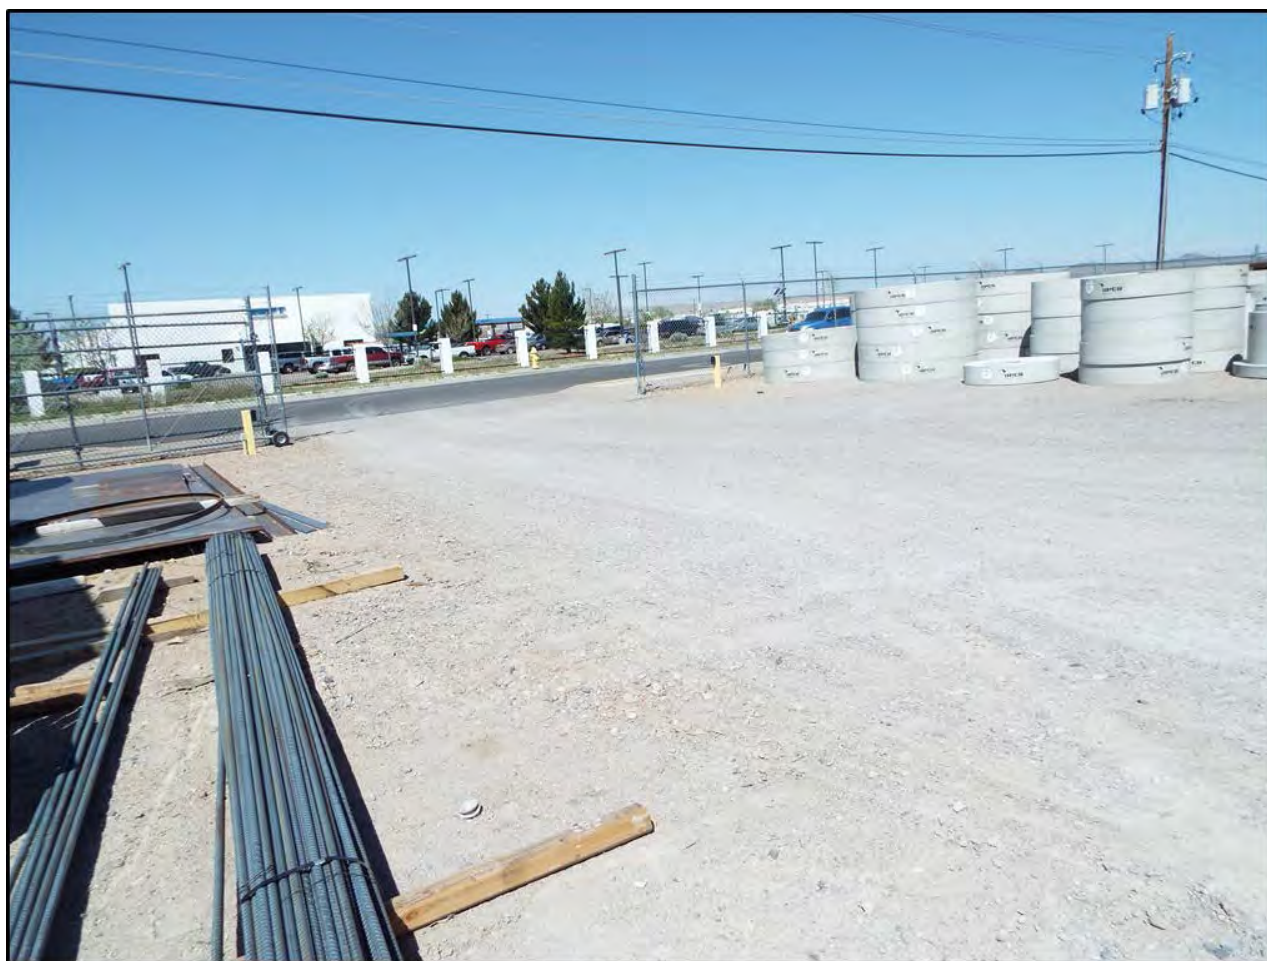
Photo # 5

Photographer: Daniel Valenta	Date: 4/12/2017	Time: 1050 hours
City/County: Albuquerque/Bernalillo		
Location: 300 Airport Rd. NW		
Subject: Material is tracked offsite at the entrance/exit to facility.
